Hewitt Technologies Inc. – Hewitt-Tech.com

Gen-I Secondary Air Injection System (SAIS) Bypass Kit Addon

Pump Proxy Pack (PPP) Installation Instructions – Rev.2

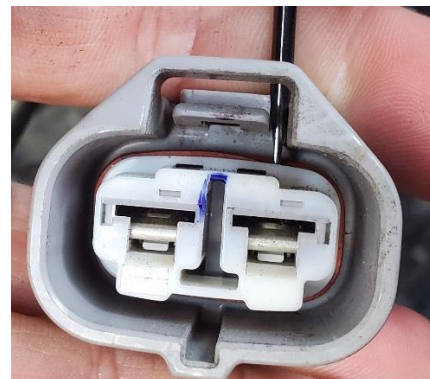
Figure 4 -Bank 1 Pump Driver Connector

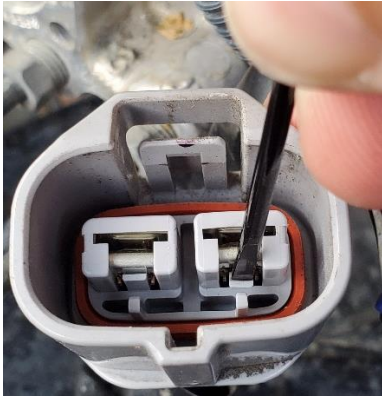
- 4) Remove the #2 Terminal by carefully catching the plastic terminal release and gently prying it out of the metal terminal body. While holding the terminal release clear of the terminal, pull the wire and terminal out of the connector.

Figure 5 - Disengaging Terminal

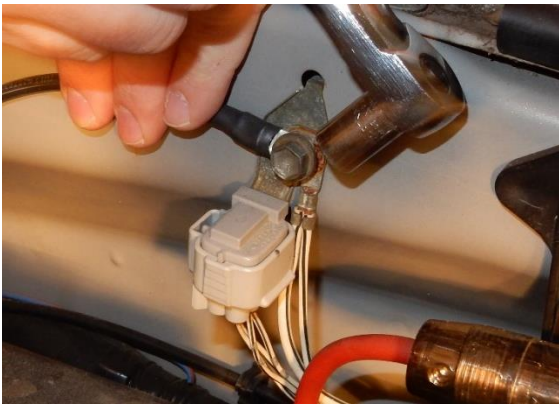
- 5) Bend the removed wire back to and tape over with electrical tape to secure and insulate the terminal.
- 7) Insert the PPP's female terminal into the vacant #2 position of the connector. It should stop when the retainer tab clicks into place. Reinstall the white terminal lock and reconnect to the air injection control driver.

Figure 7 - Connecting the Pump Pack's GND Connection

- 8) Find and remove a local body ground bolt. Any good clean body ground connection will work. Place the PPP's ring terminal under the bolt head and bolt back to the body.
- 9) If not already done, install your bypass kit and block off plates.
- 10) Reconnect your battery and start the engine. If it stalls, that is normal. Restart and let idle for 10 min to relearn fuel trims and the idle.
